## Retrieval Technique for Fractured Implant Abutment Screw: A Case Report

Fractured Abutment screw is one of the complications of Implant-supported prosthesis. Removal of this screw becomes utmost important task in the clinical situation. There are many techniques mentioned in the literature such as implant repair kits, ultrasonic scaler tips to deal with this clinical situation. This case report presents a method to remove such fractured component which is cost effective, easy, and does not require elaborate equipment.

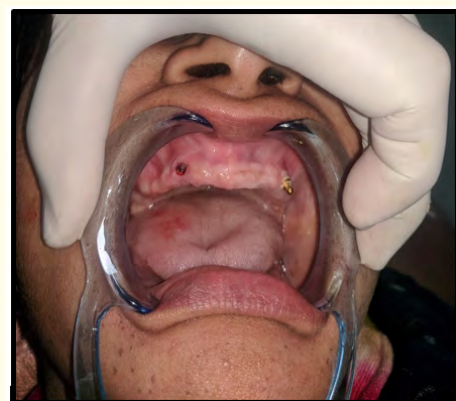
An edentulous patient reported to the Department of Prosthodontics, in this institution complaining of loose upper denture. On examination it was found that the patient was using the two implant supported overdenture and the abutment in the first quadrant (canine region) was fractured (Figure 1).

**Figure 1:** Implants placed in maxillary arch - 13 and 23 areas.

Apical part of the broken screw was retained in the implant. Both implants were radiographically examined and showed no sign of peri-implantitis and had osseointegrated properly. Two treatment options were considered: retrieval of the screw or replacing the implant. Patient was properly informed and with the consent of the patient retrieval of screw was planned.

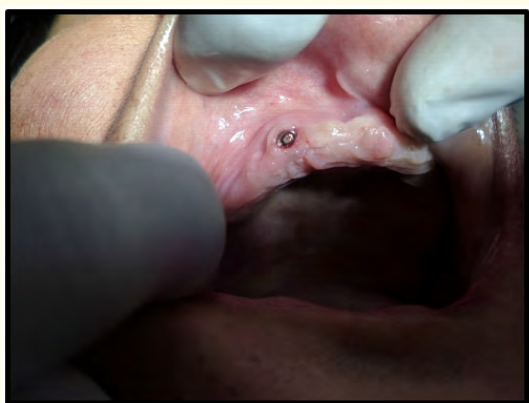
**Figure 2:** Abutment screw fracture in 13 implant head.

Implant screw hole was flushed with air and dried to have a better view and accessibility (Figure 2). Round bur (SS White, New Jersey/ size 1/4) was placed in the high speed air rotor. The bur was placed on the top of the screw head in off centred position. After proper orientation, the handpiece was activated to create a small depression.

Then a tungsten carbide bur (SS White FG-271, New Jersey) was placed in the depression to create a notch. After successfully creating the notch in the screw head, a sharp probe was engaged in it. The probe was rotated in the counter-clockwise direction. The fractured screw head was retrieved successfully (Figure 3). A new ball abutment was placed in the implant at the torque of 35 Ncm using a torque wrench. The fit of the prosthesis and implant was carefully evaluated and patient was placed on maintenance recall schedule.

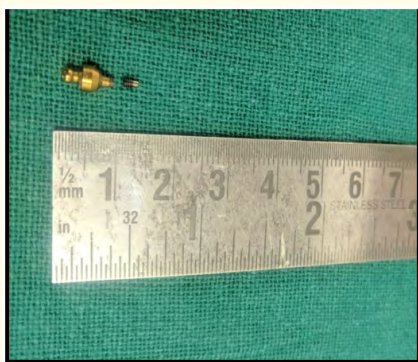
**Figure 3:** Retrieved screw of ball abutment.
