Retrieval of Fractured Ni-Ti Rotary Instrument from Root Canal using Ultrasonics and File Braiding Technique Under Surgical Operating Microscope

Case Report

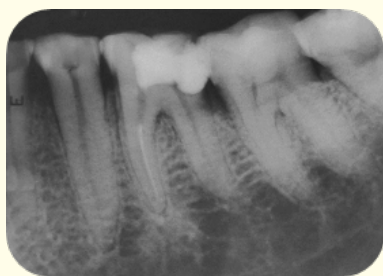
An intraoral periapical radiograph revealed the separated instrument (approximately 11 mm length) at the junction of the coronal and middle third of the canal (Figure 1).

Figure 1: IOPA xray showing fractured instrument in mesial root of lower left mandibular molar and presence of PDL space widening.

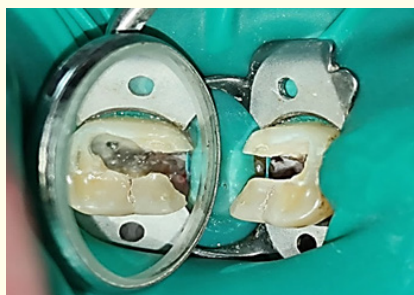
When viewed the coronal part of the separated instrument was visible inside the mesio-buccal canal and was threaded into the dentin (Figure 2).

Figure 2: Upon access opening mesio-buccal root shows presence of fractured file.

The surrounding dentin was troughed all around the fractured instrument using ultrasonically activated tip number ET25 mounted on handpiece (Eighteeth, Ultra-X) under continuous irrigation. This was done to free the coronal end of the fragment. The fractured fragment was gently bypassed using K-file ISO size 15 and with the use of 17% EDTA to the full working length (25 mm) and enlarged up to size 35. Thus space was created between the fragment and the canal wall.

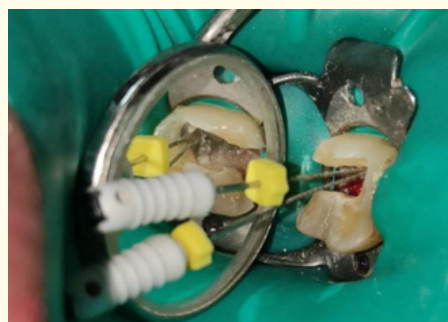
Figure 3: File braiding to engage the fractured instrument using two 15 H-files.

As the fractured file could not be recovered using repeated 'push and pull' motions, the file braiding technique was employed wherein the fractured instrument was engaged as deep as possible with the help of two new H-files of ISO sizes 15 and 15 (Maillefer, Dentsply, USA). Braiding of these files and a short outward pull resulted in the instrument being removed from the canal (Figure 3-5). A radiograph was taken to confirm the complete removal of the broken instrument (Figure 6).

Then the file braiding technique was employed in the present case with two new 15K H-files that were braided and a short outward stroke that retrieved the fragment.

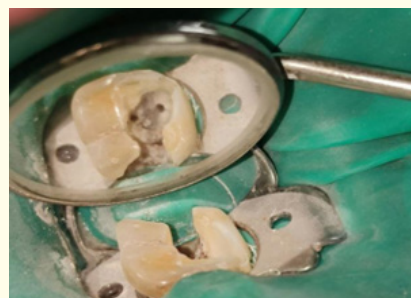
Figure 4: Intraoral picture following the fractured file removal.
