Conservative Management of Broken Endodontic Instruments: Two Case Reports

Case Report N°1

Case Report N°2

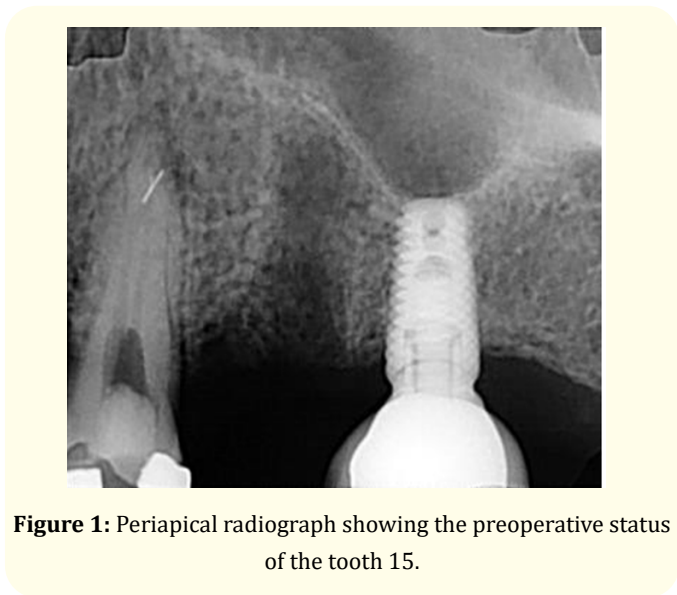
Upon clinical examination, the patient was asymptomatic, with no reported pain or discomfort. There were no evident signs of periapical pathology observed on the preoperative periapical radiograph (Figure 1).

The periapical radiograph confirmed the precise location of the separated file within the canal, situated in the apical third of the root (Figure 1).

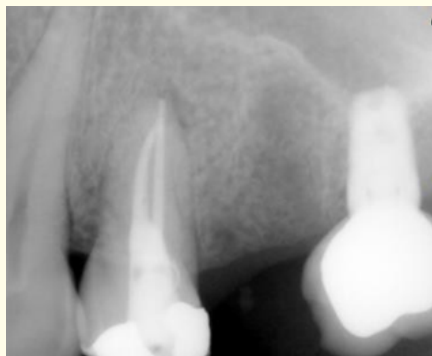
A post-operative radiograph (Figure 3) was taken to verify the quality of the obturation, and a permanent coronal restoration was completed one week later.

Figure 3: Post-operative periapical radiograph showing the filled root canals including the bypassed file.

The canals were then filled using a Gutta percha cone and a resin-based sealer (Adseal from Metabiomed), employing the single cone technique.

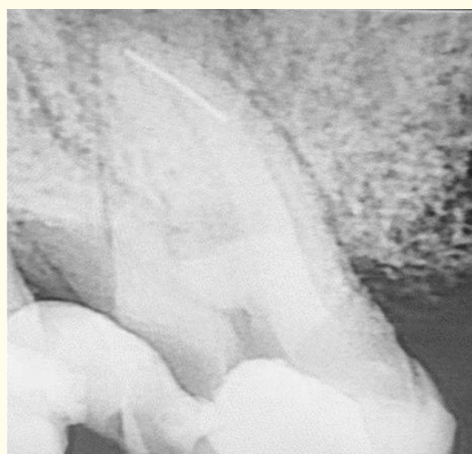
The patient presented with a challenging scenario: A broken file was lodged in the second mesiobuccal canal of the upper right first molar.

The radiograph confirmed the location of the file in the apical third of the canal, extending beyond the canal curvature (Figure 4).

Figure 4: Periapical radiograph showing the preoperative status of tooth 16.

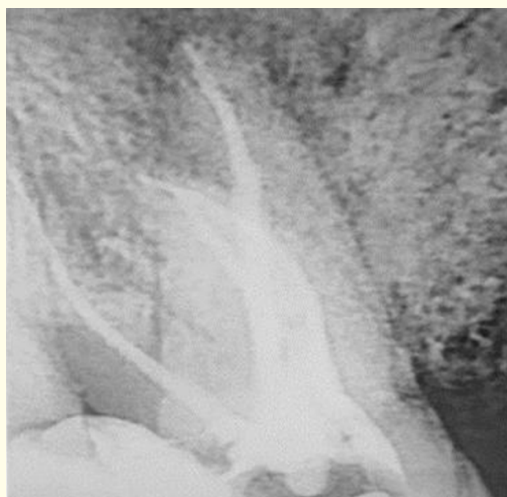
A post-operative radiograph was taken to document the quality of the endodontic obturation and treatment outcome (Figure 7).

Figure 7: Post-operative periapical radiograph showing the filled root canals of the tooth 16.

Following successful retrieval, the canals were further shaped using the XP Endo Shaper system (FKG) and then filled with a gutta-percha cone and resin-based sealer (Adseal from metabiomed) in a single visit using the single cone technique.
