Pseudoaneurysm of the Superficial Femoral Artery After Cephalomedullary Nailing in An Intertrochanteric Fracture

Abstract

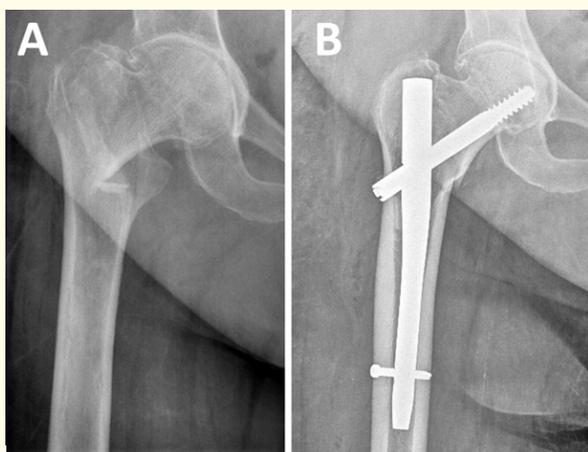
Figure 1: A: Right intertrochanteric femoral fracture; B: Immediate postoperative X-ray showing adequate fracture fixation with Gamma3® (Stryker®) nail.

Conventional X-ray revealed an intertrochanteric fracture of the right femur (AO/OTA 31A1.2, Figure 1). Surgery was done on the first day after the injury. Closed reduction was achieved by traction, adduction and internal rotation of the limb. Internal fixation was performed with Gamma3® nail (Stryker®, Mahwah, NJ) system with distal locking screw. Before the drilling of the distal locking screw, traction was removed, and the limb was placed in neutral position. There were no complications during surgery with minimal blood loss and, in the postoperative radiographic control, correct reduction of the fracture and adequate positioning of the osteosynthesis material was observed.

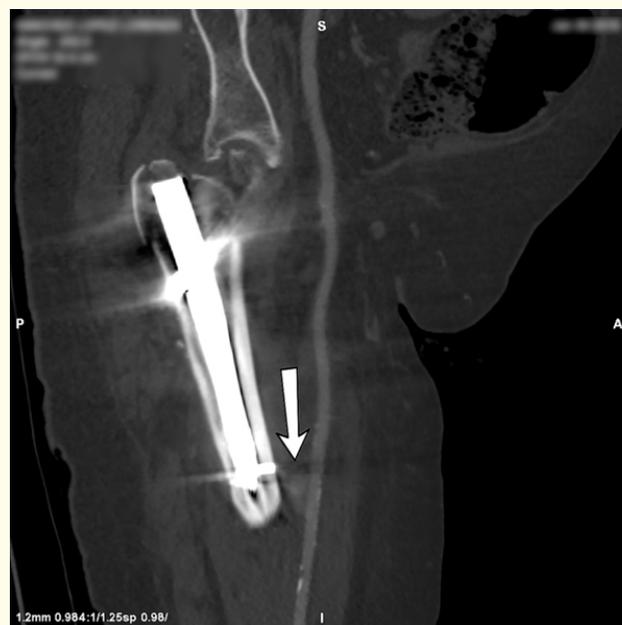
Figure 2: CT angiography showing the pseudoaneurysm of the superficial femoral artery (arrow).

During early postoperative period, the patient complained severe pain in the proximal right thigh, developed a vast hematoma in the lateral aspect of the thigh and a progressive anaemia with a minimum hemoglobin level of 7.1 g/d and 20.7% of hematocrit. We observed a falling hemoglobin trend over the next twelve days that required the transfusion of seven units of packed red blood cells without achieving adequate post-transfusion hemoglobin levels. Suspecting vascular injury with active bleeding, a computed tomography (CT) angiography was performed, revealing a false aneurysm in the right superficial femoral artery near the distal locking screw (Figure 2). The interventional radiology team of our center was contacted and the patient underwent surgery by introducing a 6 x 50mm Gore® Viabahn® (w. L. Gore and Associates, Inc., Flagstaff, Arizona) covered endoprosthesis and remodeling it by percutaneous transluminal angioplasty with a 7 x 40mm balloon to exclude the pseudoaneurysm (Figure 3 and 4). After that, the hematoma was reabsorbed, and the hemoglobin levels returned to normal levels. The patient needed one single packed red blood cell unit after surgery.

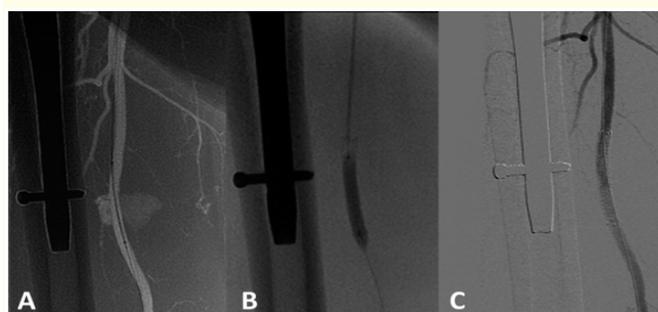
Figure 3: A: Identification of the pseudoaneurysm in the superficial femoral artery; B: Introduction of the endoprosthesis; C: Absence of pseudoaneurysm with the endoprosthesis.

Results: A Gore® Viabahn® covered endoprosthesis and posterior remodeling with percutaneous transluminal angioplasty balloon was performed to exclude the pseudoaneurysm. After that, the hematoma was reabsorbed, and the hemoglobin levels returned to normal levels, requiring one single packed red blood cell unit after surgery.

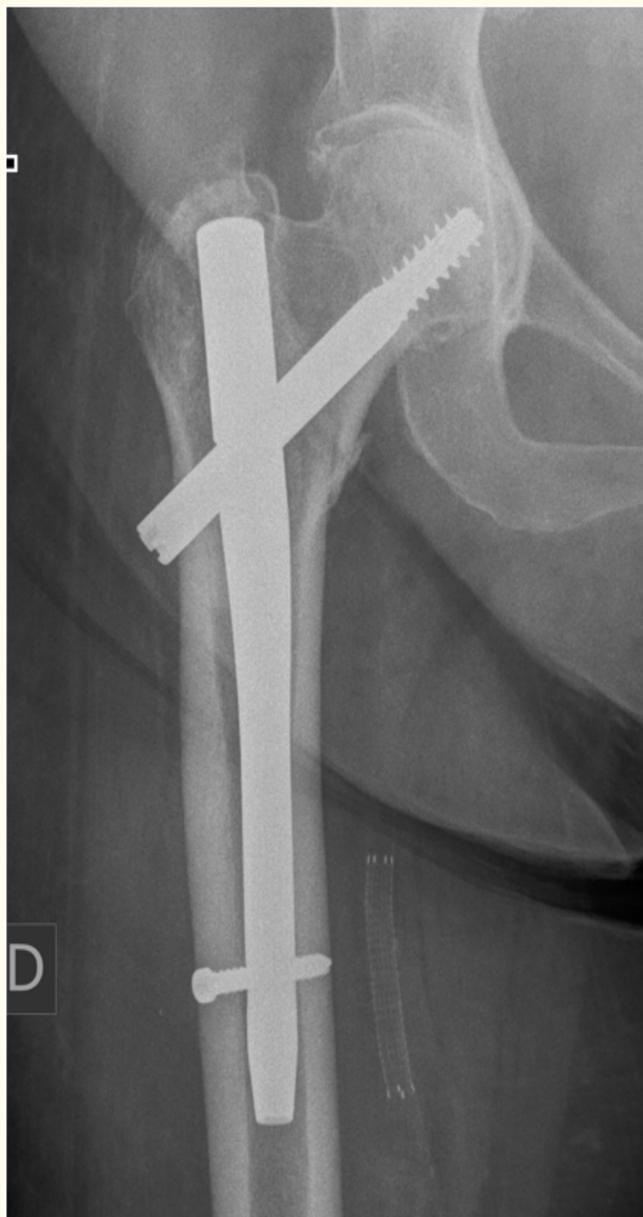
Figure 4: (conventional X-ray): Control X-ray at the 3-month follow up.
