A Cracking Tale of Ceramic Component Fracture Revision: A Case Report and Literature Review

Elliott A Ayling^{1*}, Mohammed Amer^{2,3} and Douglas Dunlop²

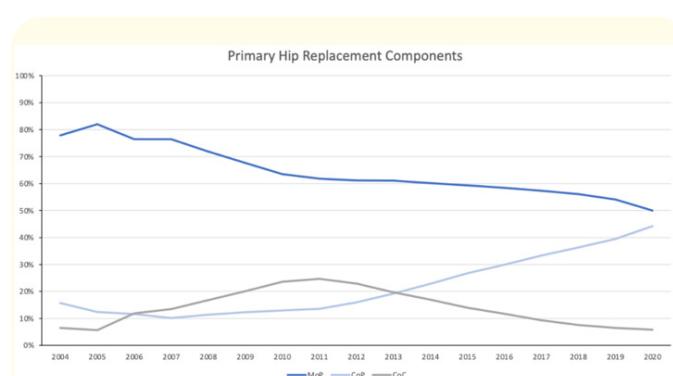
Figure 1: Changing prevalence of component selection in primary total hip arthroplasty [1].

In total hip arthroplasty (THA), metal on polyethylene (MoP) articulations are the most popular [1]. However, the use of ceramic-on-ceramic (CoC) bearings has previously gained popularity (Figure 1) due to superior wear properties [2]. This makes CoC an appealing option for the younger patient.

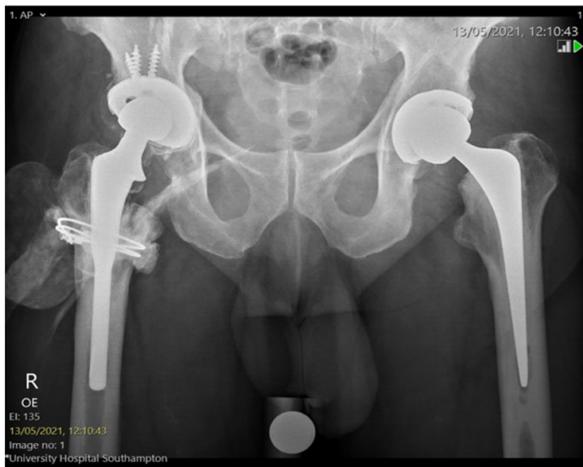
In clinic, the patient complained of persistent pain in the groin and the lateral aspect of his right hip. The patient walked with an antalgic gait and the hip was extremely irritable. X-rays showed a well-fixed stem (JRI-Furlong) and acetabular component (Trident, Stryker®). Metallosis shadowing around the component and proximal femoral osteolysis was noted (Figure 2A). Cobalt and chromium levels were 7960 and 540 nmol/l respectively.

Figure 2a: Pre-operative x-ray, note the metallosis shadow lateral to the femoral stem and the proximal osteolysis.

The patient's symptoms were attributed to metallosis caused by abrasive wear of the new metal head against the ceramic debris. The patient was counselled, consented and listed for a re-revision.

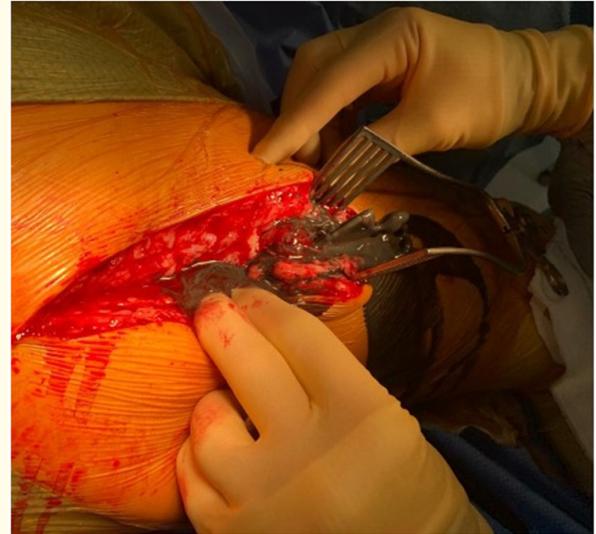
A standard posterior approach was utilized. A large collection of metallosis soup that was under tension was drained (see figure 2b). Marked asymmetrical wear of the femoral head was noted (Figure 3).

Figure 2b: Photo of the release of the metallosis soup under tension.

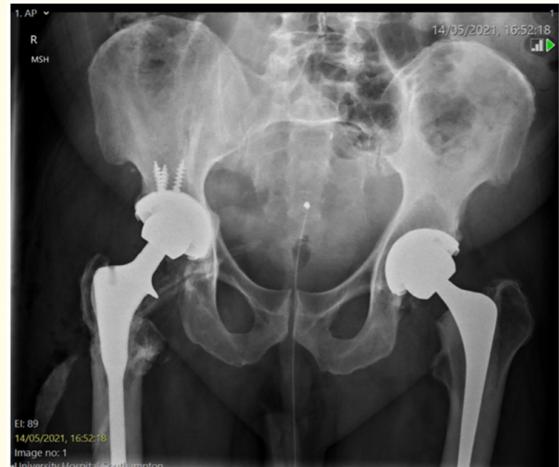
Figure 2c: X-ray depicting decreased opacity of shadowing of metallosis.

Postoperative x-ray demonstrates the resolution of the radioopaque metallosis soup (Figure 2c).

Following extensive debridement and synovectomy, a new polyethylene liner was inserted and a Bio-ball adaptor (Merete Medical Inc.) was mounted on the trunnion and a ceramic head mounted on the adaptor.

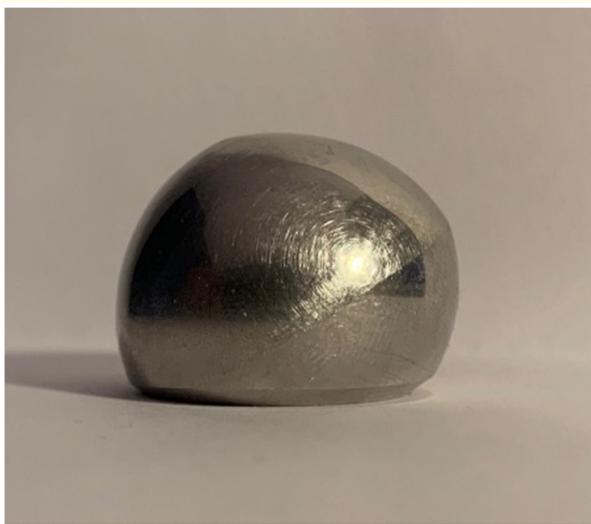
Figure 3: Tangential view of femoral head showing marked deformity due to wear.

Our findings of a deformed metal femoral head at the head/liner interface, ceramic dust within the liner and the significant metallic debris within the joint all support the third body abrasive wear theory.

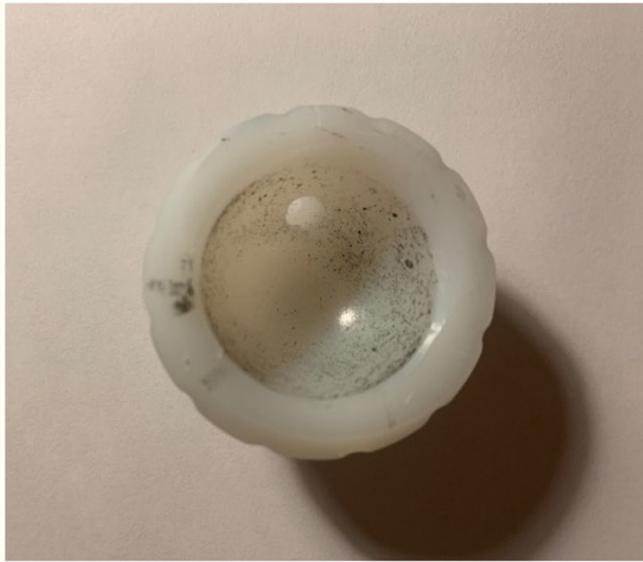
Significant trunnion damage was observed but was deemed fit for use. Surprisingly there was no evidence of wear on the femoral head at the head/trunnion interface. Ceramic particles embedded within the polyethylene liner could be seen grossly (Figure 4).

Figure 4: Black particulates of ceramic embedded in the original polyethylene liner acting like sandpaper on the femoral head.

Similar findings were reported extensively in the literature [6,7,10,11]. The harder ceramic debris is embedded in the soft polyethylene and acts as sandpaper rubbing against the metal femoral head releasing metallic debris. The debris mimics failing MoM replacements and is known as an adverse reaction to metal debris (ARMD). Allain, *et al.* reported the biggest series to date [7]. A higher revision rate and worse outcomes were associated with the use of stainless heads compared to other combinations as it is more liable to the sandpaper effect. Traina and Trebše reported higher rates of radiologic loosening with the use of a MoP compared to ceramics [6,9]. The systemic effects of the resulting metallosis cannot be understated. Zyweil reported fatal cardiomyopathy following the use of a MoP combination in a revision of a fractured ceramic liner [12]. Locally, irreversible soft tissue damage due to ARMD can lead to a high dislocation rate [4].

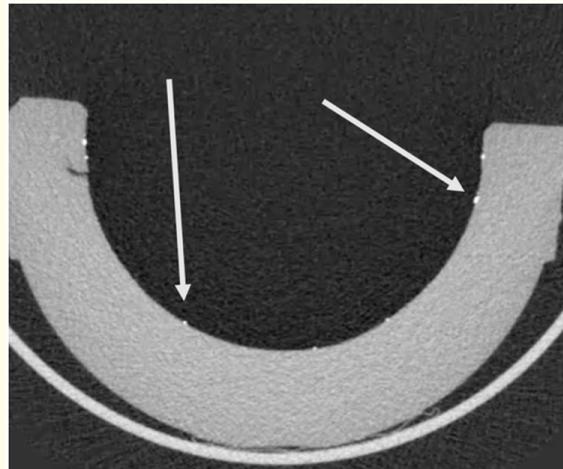
Upon review of the original revision components. A CT scan of the retrieved PE showed ceramic debris embedded on its articulat-

ing interface (Figure 5). The metal head lost 15% of its mass in the 18 months after index revision.

Figure 5: CT scan showing embedded ceramic particles (arrows) in the liner
