## Intraprosthetic Dislocation of Dual-Mobility Total Hip Arthroplasty: Analysis of a Case Series and Review of Literature

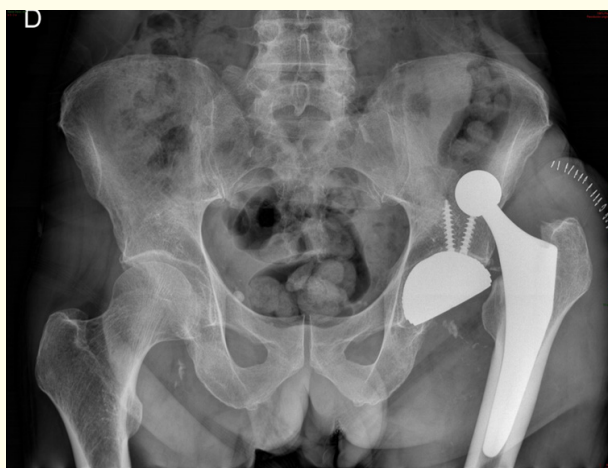
**Figure 1:** AP pelvic x-ray showing dislocation of left hip prosthesis. The staples in the surgical wound show his recent surgery.

- Case 1:** Male patient, 71 years old, with a history of stroke and THA with DM components for femoral neck fracture. He consulted in the emergency department two weeks after surgery after another fall, revealing dislocation of THA (Figure 1). A closed reduction was performed, which failed, so IPD was considered. It was decided to perform open reduction in the operating room, where the PE liner was found in the soft tissues, and the prosthetic femoral head articulating with the metal shell, without metallosis. In the same surgical procedure, the prosthesis was revised with a constrained system (Figure 2).
- Case 2:** Female patient, 76 years old, with a history of stroke and THA with DM components for femoral neck fracture.

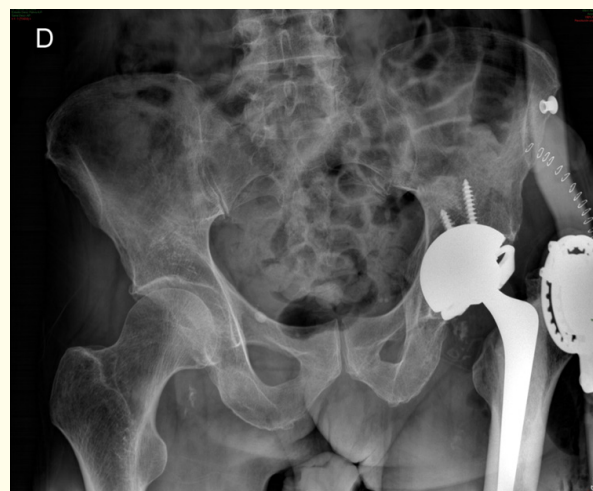
**Figure 2:** AP pelvic x-ray showing revision left THA with constrained system.

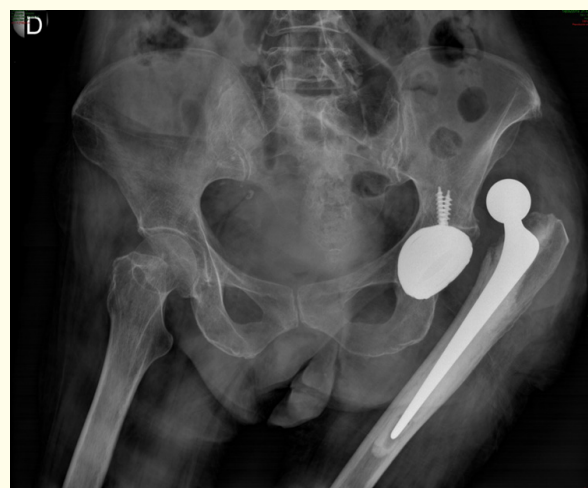
**Figure 3:** AP pelvic x-ray showing dislocation of left hip prosthesis. Above the dislocated prosthetic head there is a shadow that could correspond to the PE liner fixed to the prosthetic head.

She consulted the emergency department three weeks after another fall, revealing dislocation of her total hip prosthesis (Figure 3). Closed reduction was performed, which was laborious. In the fluoroscopy of the procedure, an eccentric head was observed, so IPD was considered. It was decided to perform open reduction in the operating room, where the PE liner was found in the soft tissues, and the prosthetic femoral head articulating with the metal shell, without metallosis. In the same surgical procedure, the total hip prosthesis was revised with reorientation of the acetabular cup and new DM components (Figure 4).

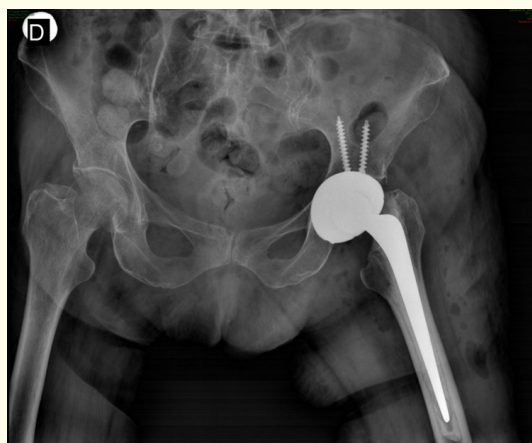
**Figure 4:** AP pelvis x-ray showing post revision left THA.

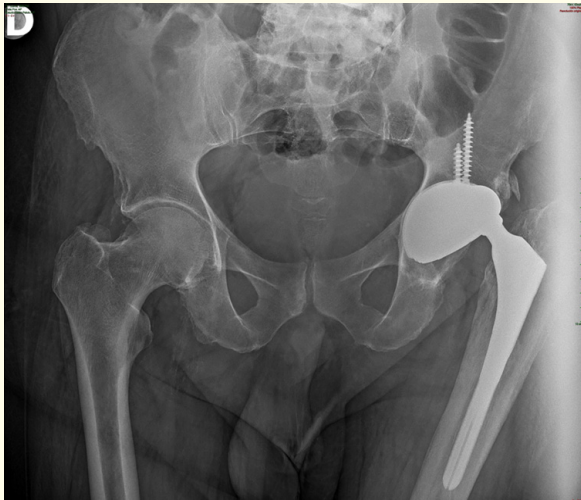
**Figure 5:** AP pelvis x-ray showing left THA dislocation.

- Case 3:** Male patient, 69 years old, with a history of revision hip prosthesis with DM components for instability. One year after surgery, he consulted the emergency department after a fall on stairs, revealing dislocation of the THA (Figure 5). A closed reduction maneuver was performed, which was considered successful, so the patient was discharged home. In the outpatient follow-up, persistent pain and sound upon hip mobilization were investigated. Simple radiology showed an eccentric head in the acetabular cup (Figure 6). IPD was considered and open reduction was indicated, which was deferred for six months due to decompensated diabetes. Intraoperatively, significant metallosis was observed, with the prosthetic femoral head articulating with the metal shell. The PE liner was not found in the soft tissues, the computed tomography showed it in the gluteal region (Figure 7). In the same surgical procedure, a new DM system was installed. Additionally, a head adapter system was installed to obtain more length and offset (Figure 8).

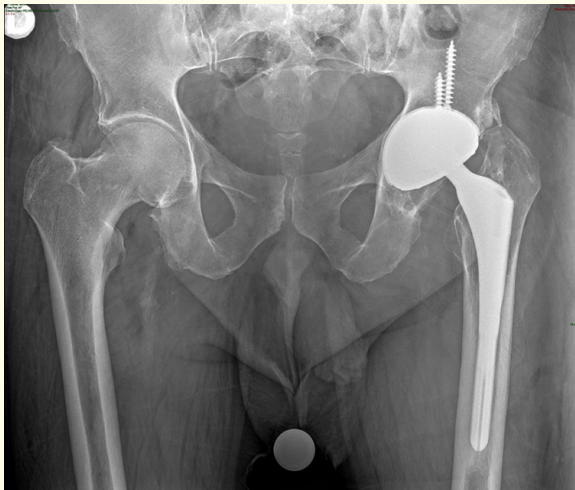
**Figure 6:** AP pelvis x-ray showing left hip prosthesis with post-reduction eccentric head, suggestive of IPD.

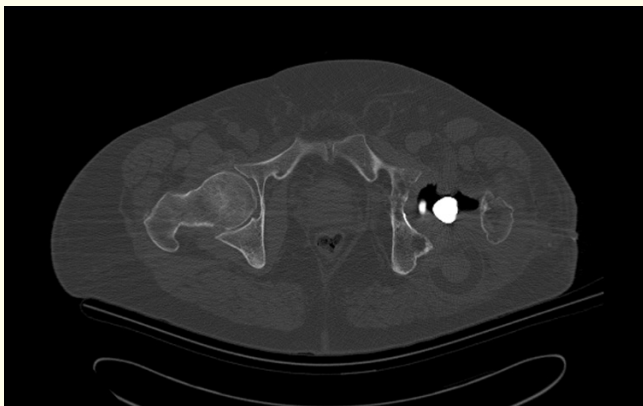
**Figure 7:** Axial section of computed tomography showing a circular image in the left gluteal region suggestive of lost polyethylene liner.

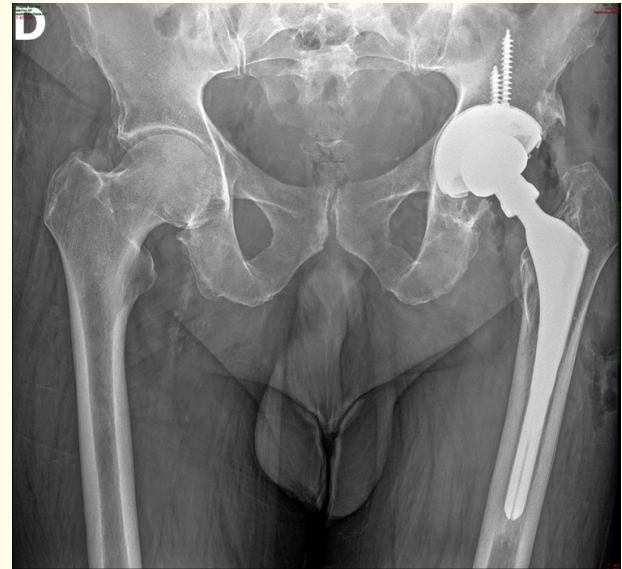
**Figure 8:** AP pelvic x-ray showing post-revision left THA. The head adapter system was used for more length and offset.
