## Accidental Dislodgement of Separated Instrument in the Maxillary Sinus: A Unusual Case

### Abstract

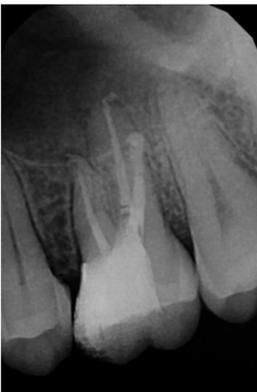
**Figure 4:** Post-operative radiograph.

An 3 mm apical plug of MTA in distobuccal canal was created using hand condensation technique. Many studies have confirmed the superior biocompatibility of MTA as a root-end filling [37]. Remaining of the canal was then obturated with warm gutta percha using backfills as it provides a closer adaptation to dentinal walls and prevents any leakage [38]. One of the Limitations of this case report was, the dependency of the case on radiographs. Artifacts produced in the radiographs affects the accuracy of the diagnosis [39].
