## The Influence of Finishing Technique on the Surface Roughness and Fracture Resistance of Different all Ceramic Crowns

**Purpose:** The aim of this present study was to examine the effect of various finishing techniques (A: Glazing, B: Re-glazing, C: Polishing) on the fracture resistance and surface roughness of In-Ceram crowns.

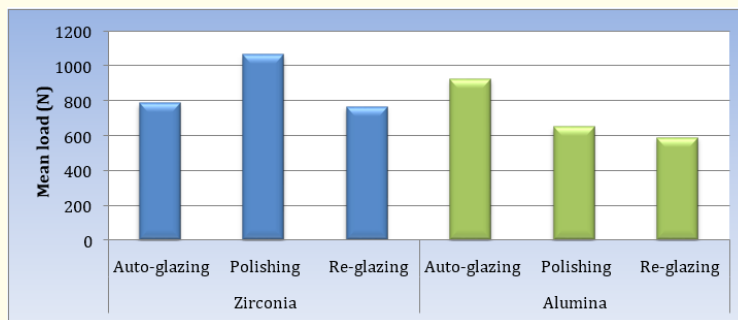
Means, standard deviations of fracture resistance of the two main tested groups are listed in (Table 1) (Figure 1).

For In-ceram zirconia group: The polishing technique showed the statistically highest mean load at failure (1063 N), while there was no statistically significant difference between auto-glazing and re-glazing techniques; both showed the statistically significantly lowest mean load at failure values (784.3 N, 763.2 N) respectively.

While for for In-ceram alumina group: The auto-glazing technique showed the statistically highest mean load at failure (922.3

**Figure 1:** Bar chart representing mean values for comparison between load at failure of the different In Ceram crowns.

N) this was followed by polishing technique (649.1 N), while the Re-glazing technique showed the statistically significantly lowest mean load at failure (585.6 N).

Concerning the effect of the finishing techniques on the fracture resistance for the In ceram zirconia group (A), the polishing technique Subgroup (III) recorded the highest mean load at failure (1063 N), while there were no differences between auto-glazing Subgroup (I) and re-glazing Subgroup (II); both recorded the lowest mean load at failure values (784.3 N, 763.2 N) respectively, regardless of finishing techniques used, and this might be due to the irregular scatters and porosities which were removed on the superficial ceramic surface after polishing procedure.

For In ceram alumina group (B) significantly decreased the fracture resistance when compared to in ceram zirconia group (B). Within the groups, The auto-glazing Subgroup (I) showed the highest mean load at failure (922.3 N) this was followed by polishing Subgroup (III) (649.1 N), while the Re-glazing Subgroup (II) showed the statistically significantly lowest mean load at failure (585.6 N), and this might be due to applied glaze lead to seal microscopic pores present on the ceramic surface that produced glossy and a satisfactory surface for ceramic restoration. This data were also supported by SEM evaluation, which showed the re-glazing Subgroup (II) was slight scatters and roughness were observed on ceramic surface in comparison with other surface techniques (I, II). And the surface roughness analysis of glazing Subgroup (II) recorded the lowest mean (Ra) values (0.248  $\mu\text{m}$ ).

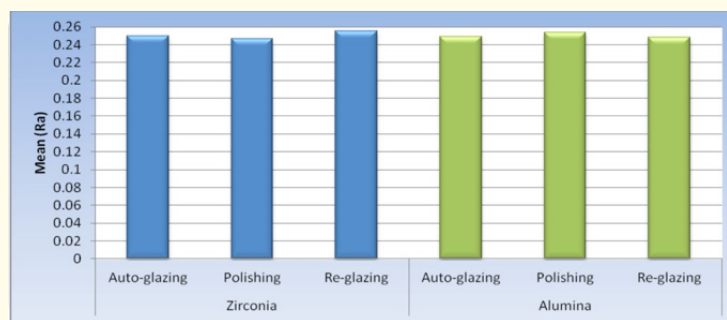
Means, standard deviations of fracture resistance of the two main tested groups are listed in (Table 2) (Figure 2).

For In-ceram zirconia: the re-glazing and auto-glazing techniques; both showed there was no statistically significant difference; both revealed the statistically significantly highest mean (Ra) values (0.255 um, 0.250 um respectively), while the polishing technique showed the statistically significant lowest mean (Ra) values (0.247 um).

While for In ceram alumina: the re-glazing and auto-glazing techniques; both showed there was no statistically significant difference; both revealed the statistically significantly lowest mean

(Ra) values (0.248 um, 0.249 um respectively), while the polishing technique showed the statistically significant highest mean (Ra) values (0.254 um).

**Figure 2:** Bar chart representing mean values for comparison between (Ra) of the different In Ceram crowns.

features on the ceramic surface in comparison with other surface techniques (I, II) and the surface roughness analysis of polishing Subgroup (III) recorded the lowest mean (Ra) values (0.247  $\mu\text{m}$ ) regardless of finishing technique used.
