Case Summary A case of Compound Comminuted Fracture around Right Elbow

Dilip D Shah*

Department of Orthopaedics, University of Bombay, India

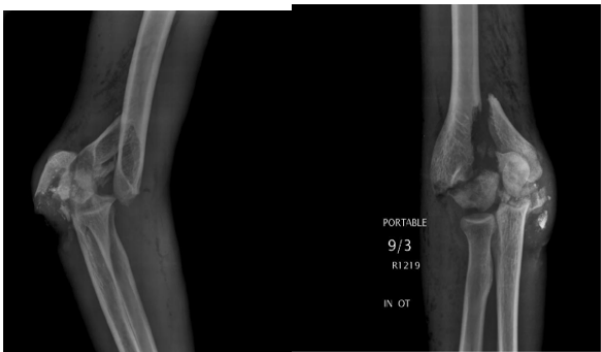
Figure 3

Portable X rays in OT at the time of Debridement with traction. (Figure 3)

In the O.T. Wound checked. Sutures removed, all dirt and debris removed with thorough NS+BETADINE+HYDROGEN PEROXIDE wash. PORTABLE x-rays were taken in the O.T. with right elbow in full extension and longitudinal traction. patient had GRADE 13-C3 AO classification DISTAL HUMERUS, COMPLETE ARTICULAR MULTIFRAGMENTARY FRACTURE WITH METAPHYSEAL WEDGE FRAGMENTATION The particular region had Fractures in Saggital as well as Coronal planes. Stay sutures taken and planned for definite surgery after 2 days.

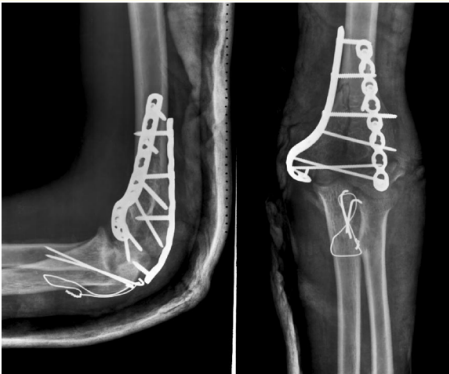
Figure 8

Immediate Post Op X Rays.

Perpendicular plating system used. Medial column fixed first with pre- contoured locking plate. Then k-wires used as joystick to manoeuvre articular fragment and fixed with pericortical inter- fragmentary screws. Lateral column fixed with Recon locking plate. Olecranon reattached to the shaft of the ulna with tension band wire system. Wound closed and Ulnar nerve was left in the same position (not Transposed) and POP slab given.
